Model NR3XLEC

Pressure Reducing Valve with Integral By-pass and Pressure Relief Valve
(1/2", 3/4" & 1")

REPAIR KIT INSTRUCTIONS

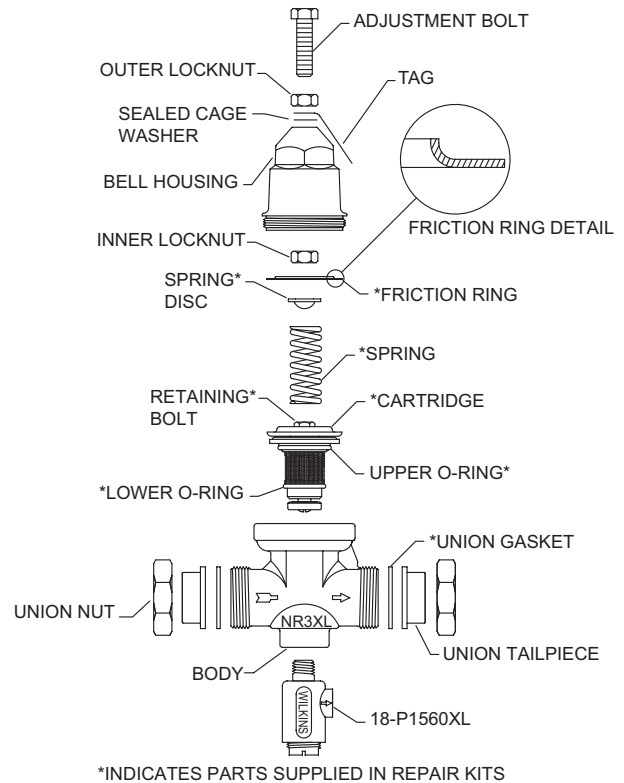
1. Note distance that adjustment bolt protrudes from bell housing. Loosen locknut on adjustment bolt, then turn adjustment bolt out of bell housing until free of spring tension.
2. Unscrew bell housing counterclockwise and remove spring, spring disc and friction ring.
3. Remove cartridge from regulator by gripping retaining bolt with pliers and pulling outwards away from body.

1. Open shut-off valve slowly and flush body and line of any debris.
2. Replace old cartridge assembly with new cartridge assembly. Prior to installation, apply a small amount of lubricant to cartridge o-rings. The cartridge is pushed into bore on body and seals against o-rings.

3. Install new spring, spring disc and friction ring. Make sure friction ring is installed with raised edge facing up (friction ring detail).
4. Replace bell housing by tightening clockwise (Be sure not to over-tighten.). Turn adjustment bolt clockwise until adjustment bolt touches spring disc.

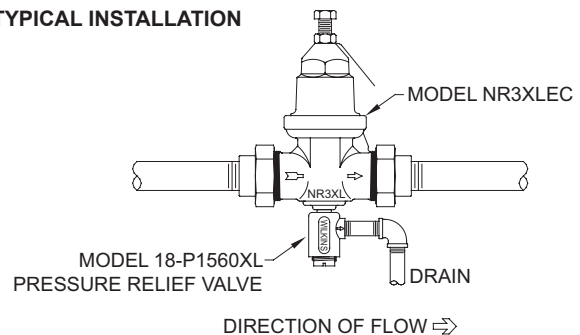
TYPICAL INSTALLATION

Install valve in line with arrow on valve body pointing in direction of flow. Before installing reducing valve, flush out line to remove loose dirt and scale which might damage seal ring and seat. All valves will be furnished with stock settings to reduce to 50 psi. To readjust reduced pressure, loosen outer locknut and turn adjustment bolt clockwise (into bell housing) to raise reduced pressure, or counterclockwise (out of bell housing) to lower reduced pressure.

WARNING: Attach drain line to relief valve and plumb to a safe location. The drain line should terminate at a location where discharge of water will not cause damage or general discomfort.

Regulators in series: Where the desired pressure reduction is more than a 4 to 1 ratio (i.e. 200psi to 50psi), multiple regulators in series should be installed.
